1. REPORT DATE (DD-MM-YYYY) October 2013		2. REPORT TYPE Technical Paper		3. DATES COVERED (From - To) October 2013- December 2013	
4. TITLE AND SUBTITLE FAILURE ANALYSIS OF HIGH PRESSURE TEST FACILITY CONTROL VALVES			5a. CONTRACT NUMBER In-House		
			5b. GRANT NUMBER		
			5c. PROGRAM ELEMENT NUMBER

FAILURE ANALYSIS OF HIGH PRESSURE TEST FACILITY CONTROL VALVES

P. M. Rice, M.S., P.E, M. Heitstuman, B.S.M.E., 1LT, USAF & J. Blanton, B.S.M.E., 2LT, USAF
Air Force Research Laboratory, Aerospace Systems Directorate, Rocket Propulsion Division
Edwards AFB, CA

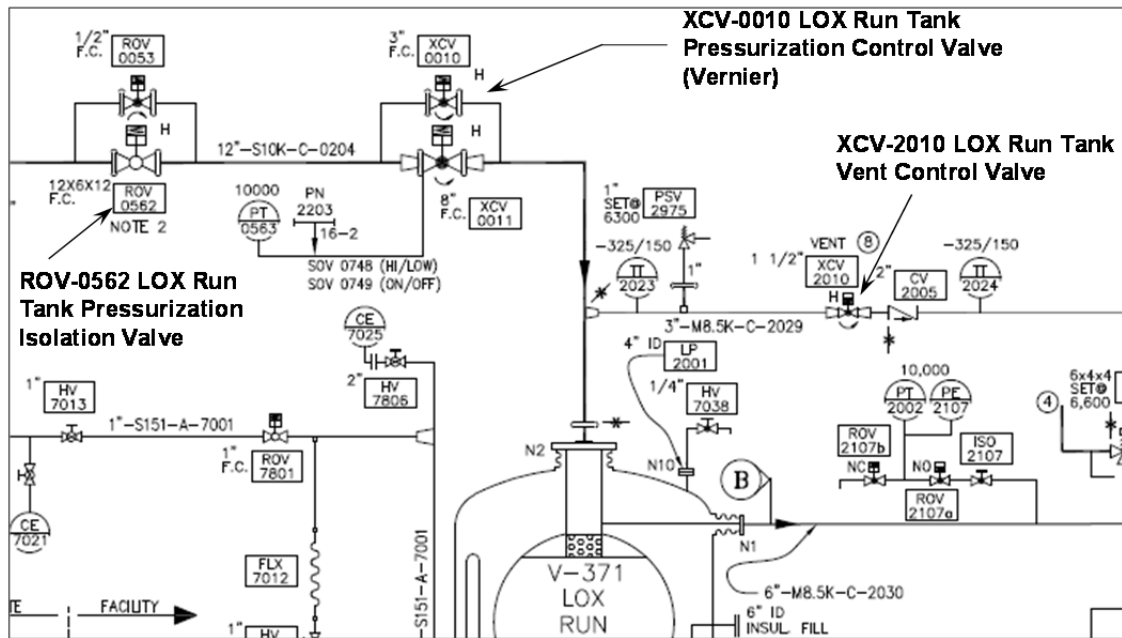
Figure 1. This schematic Process and Instrumentation Diagram (P&ID) shows how the LOX run tank is pressurized from the GN2 cascade, as well as the system used to vent the tank.

During initial blowdown tests, we started to notice anomalies in the tank vent rate data that made us suspect the vent control valve (XCV-2010) may have been leaking. The leak rate quickly became untenable once the pressurization system reached 5,000 psig. Not only was the leak now obvious in the data, but was clearly audible out on the test stand. Testing was temporarily suspended in order to fix the problem. Leaking control valves are not unusual, especially large metal-seated globe valves operating at very high pressure. We have a great deal of experience and expertise working with these valves, and therefore proceeded with our standard “fix” for the leak; minor mechanical adjustments, and control system calibration to ensure that the plug was properly seated in the body of the valve. (Note the mechanical engineers automatically default to the problem being a control system problem, and vice-a-versa). These fixes are generally successful; however, in this case, they proved to be futile. The leak continued until it abruptly increased during a blowdown test whereupon we (the mechanical engineers) admitted defeat and acknowledged that the cause could only be attributed to a significant mechanical failure. We performed a borescopic examination and discovered significant damage to the valve plug and seat. The valve was removed, examined, and determined to be severely damaged and irreparable. A substitute valve was installed and activation tests resumed.

Shortly after the activation tests restarted, we noticed that the tank pressure was rising quickly after the tank vent valve (replacement XCV-2010) was closed. This was noted while performing routine leak checks on the main tank Pressure Safety Valve (PSV). This pressure increase was significantly higher than anything we had seen in any previous operation. The only credible source of the gas that could pressurize the tank was via XCV-0010. (Note that XCV-0011, the main tank pressurization valve, was not used or required to support this test series. It was mechanically locked closed and previously leak checked). Based on the failure of XCV-2010, we (the mechanical engineers) bypassed blaming the controls and instrumentation folks, and proceeded under the assumption the valve had mechanically failed. This was not an unreasonable assumption for three reasons: 1) the failure was much more abrupt than the vent control valve failure, 2) the leak rate was very large, and 3) the valve was from the same manufacturer and of the same design as the vent valve. Borescopic examination confirmed significant damage to the valve plug and seat. We removed, examined, and determined the valve to be severely damaged and non-repairable. A substitute valve from a different manufacturer

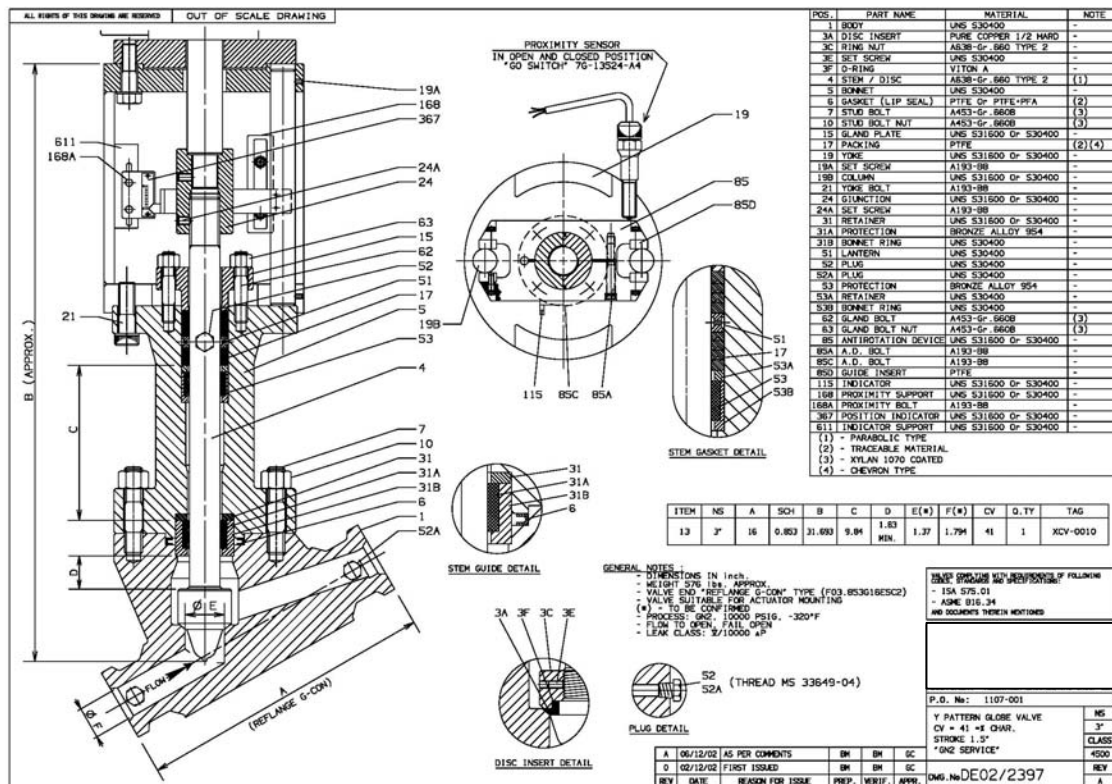
In **Figure 2**, we show the basic configuration of XCV-0010. The valve is a hydraulically actuated Y-pattern globe valve. The body of the valve is constructed from 304 stainless steel and the plug and stem are made from A286 Gr 660 Type 2 stainless steel. The plug is a three-piece design with a copper seat.

Figure 2. A cross sectional view of XCV-0010 shows the basic configuration of the valve. This configuration, consisting of a Y-pattern body, plug and stem, guides, and packing, is a common configuration for high-pressure globe valves, which has been used for over 60 years.
